Property Inspection Report

Property address: **703 North Main Road
Dothan, AL 36301**

Inspection date: Wednesday, March 9, 2022

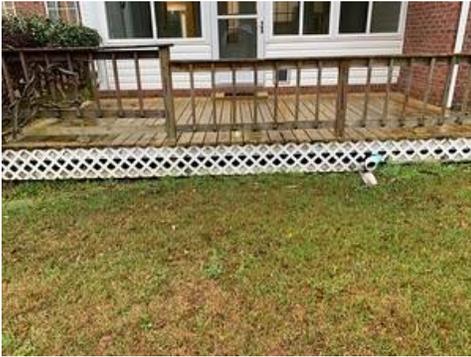
Photo 2-1

Soil was in contact with one or more wooden deck, porch or balcony support posts. This is a conducive condition for wood destroying organisms. Even if posts are made of treated wood, the cut ends below soil may not have been field treated. Recommend grading soil or repairing as necessary to prevent wood-soil contact.

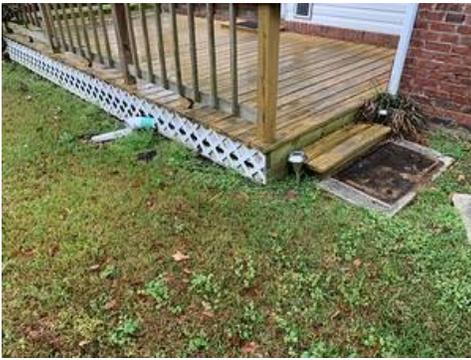
Photo 3-1

Soil was in contact with or too close to wooden deck, porch or balcony substructure components. This is a conducive condition for wood-destroying organisms. Clearances to soil should be as follows:

Pressure treated wood is typically rated for 25 year contact with soil, but the cut ends hidden below grade may not have been treated and can rot quickly. Support posts should be elevated above grade on concrete piers or footings, and be separated from the concrete by metal brackets or an impermeable membrane such as shingle scraps. For other components, soil should be graded and/or removed to maintain these clearances if possible. Otherwise, replacing non-treated wood with treated wood, or installing borate-based products such as Impel rods may help to prevent infestation and damage. For more information, visit:

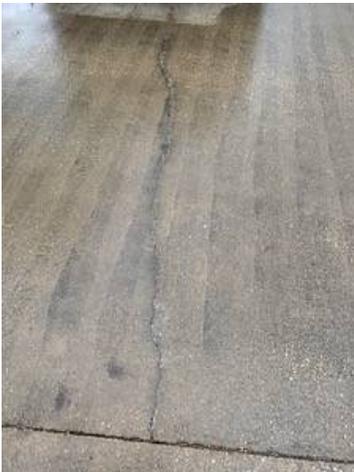
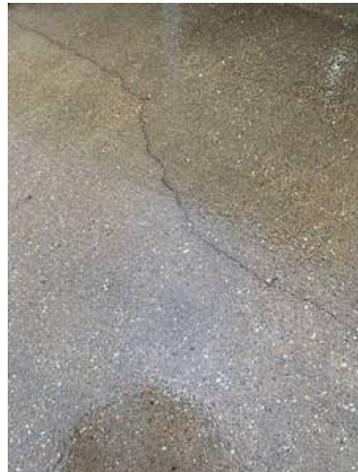
Minor deterioration (e.g. cracks, holes, settlement, heaving) was found in the driveway, but no trip hazards were found. The client may wish to have repairs made for cosmetic reasons.

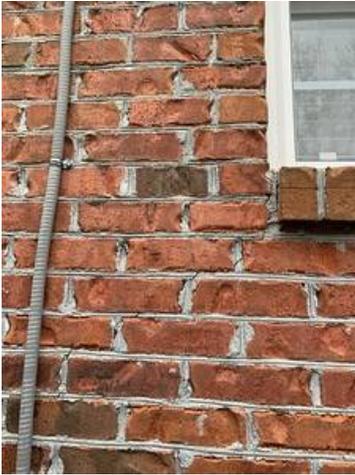
Photo 7-1

The masonry (brick or stone) veneer was deteriorated or damaged in some areas. Where cracks or openings are exposed, water may enter the wall structure causing mold, fungal growth and structural damage. This is a conducive condition for wood-destroying organisms. Recommend that a qualified contractor repair as necessary. For example, by repointing mortar or replacing broken or missing masonry.

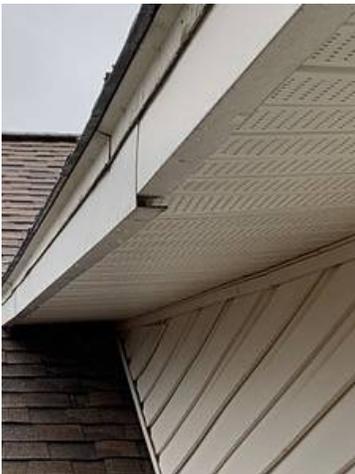
Photo 8-1

Some sections of siding and/or trim were loose. Recommend that a qualified person repair, replace or install siding or trim as necessary.

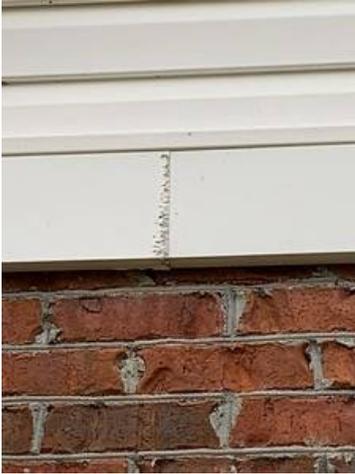
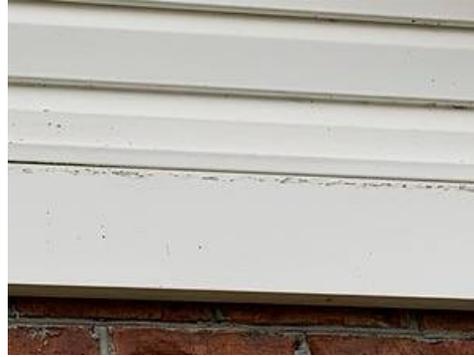
The paint or stain finish in some areas was failing (e.g. peeling, faded, worn, thinning). Siding and trim with a failing finish can be damaged by moisture. Recommend that a qualified contractor prep (e.g. clean, scrape, sand, prime, caulk) and repaint or restain the building exterior where necessary and per standard building practices. Any repairs needed to the siding or trim should be made prior to this.

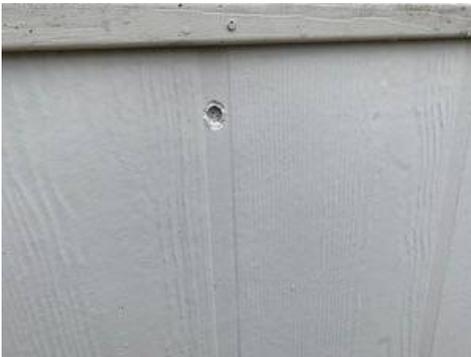
Photo 10-1

Caulk was deteriorated in some areas. For example, at siding-trim junctions. Recommend that a qualified person renew or install caulk as necessary. Where gaps are wider than 1/4 inch, an appropriate material other than caulk should be used. For more information, visit: <http://www.reporthost.com/?CAULK>

Screw holes.

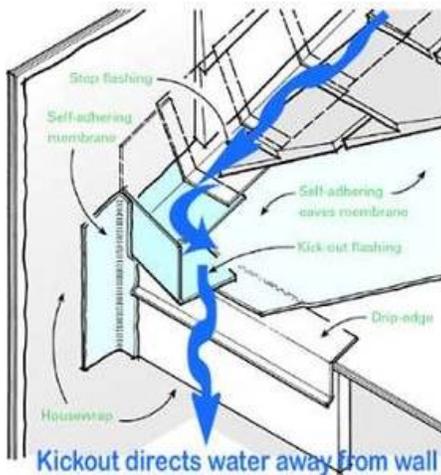
Photo 11-1

Kick-out flashing was missing at one or more locations. Such flashing should be located at the bottom of slopes where roof surfaces intersect with exterior walls above. It directs rainwater away from exterior walls and into gutters so that rainwater is less likely to run down the front surfaces of siding or flow behind siding. Recommend that a qualified contractor install kickout flashings where missing and per standard building practices.

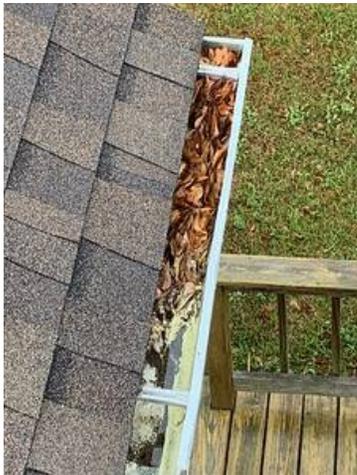
Photo 12-1

Significant amounts of debris have accumulated in one or more gutters or downspouts. Gutters can overflow and cause water to come in contact with the building exterior, or water can accumulate around the foundation. This is a conducive condition for wood-destroying organisms. Recommend cleaning gutters and downspouts now and as necessary in the future.

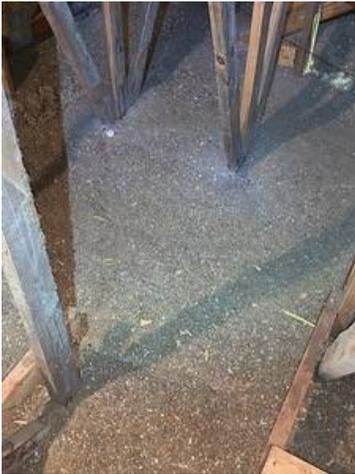
Photo 14-1

The ceiling insulation in one or more areas of the attic was compacted or uneven. Heating and cooling costs may be higher due to reduced energy efficiency. Recommend that a qualified person repair, replace or install insulation as necessary and per standard building practices (typically R-38).

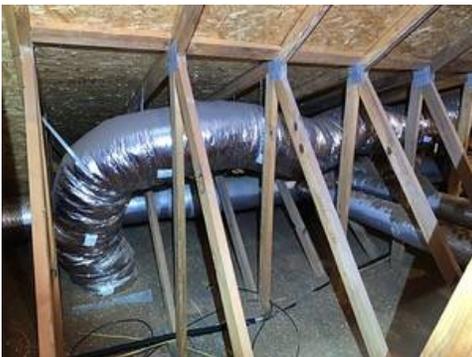
Photo 15-1

Attic access point(s) had some areas that were inaccessible because ducts or pipes were blocking. These areas were not evaluated and are excluded from this inspection. The condition of these areas is unknown.

Limited height and could cause damage to insulation.

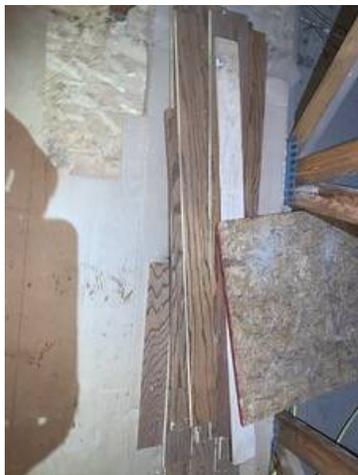
Photo 16-8 Extra materials stored in the attic.

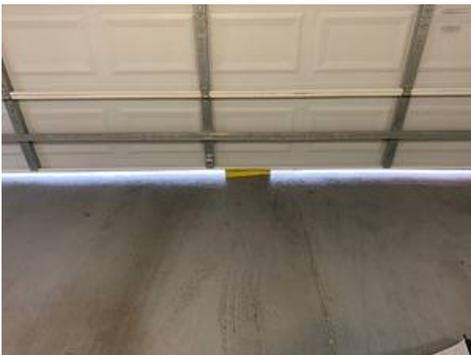
Photo 18-1

The auto-reverse mechanism on one or more automatic openers for garage vehicle doors was inoperable. This is a potential safety hazard. A qualified contractor should evaluate and repair as necessary. For more information on garage door safety issues, visit:

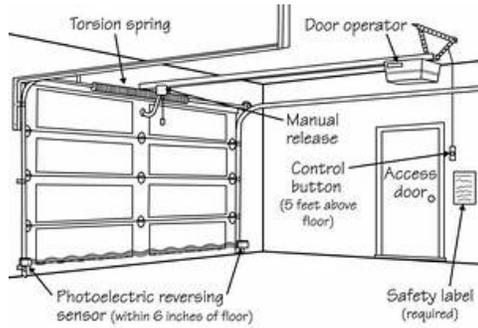
Photo 19-1

The photoelectric sensors that trigger the auto-reverse feature on one or more garage vehicle doors' automatic openers were located higher than 4-6 inches from the floor. This is a potential safety hazard. A qualified person should relocate sensors so they are 4-6 inches from the floor per standard building practices. For more information on garage door safety issues, visit: <http://www.reporthost.com/?GDPES>

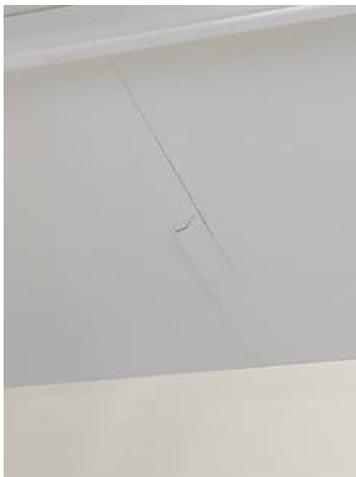
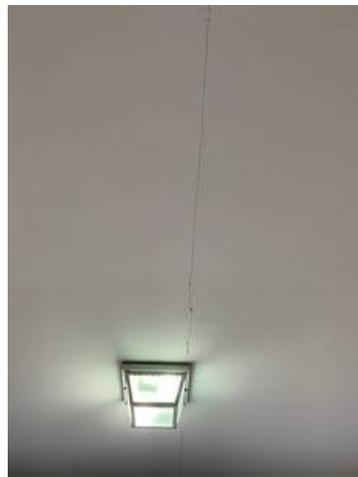
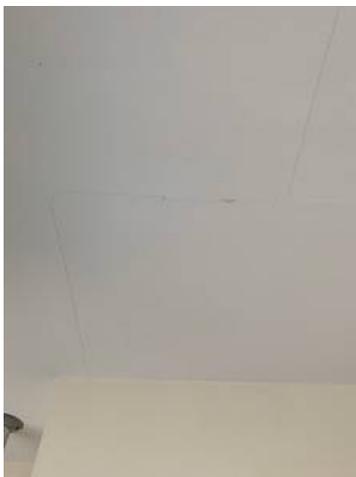
Minor cracks in garage walls and ceiling.

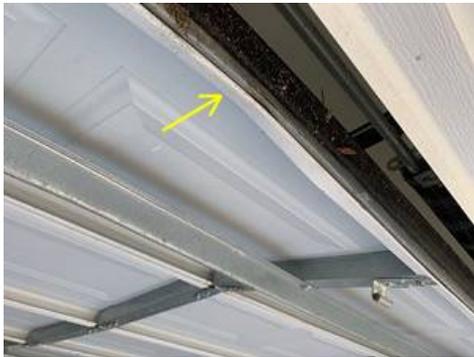
Photo 21-1

21) **i** One or more garage vehicle doors had minor damage or deterioration.

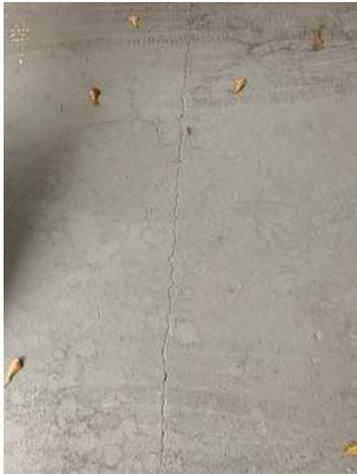
Photo 22-1

22) **i** Minor cracks were found in the concrete slab floor. These are common and appeared to be only a cosmetic issue.

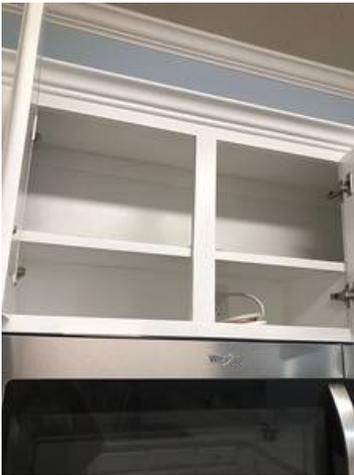
Photo 23-1

The exhaust fan over the range recirculated the exhaust air back into the kitchen. This may be due to no duct being installed, baffles not being installed, or problems with duct work. This can be a nuisance for odor and grease accumulation. Where a gas-fired range or cook top is installed, carbon monoxide and excessive levels of moisture can accumulate in living spaces. Recommend that a qualified contractor evaluate and repair as necessary so exhaust air is ducted outdoors.

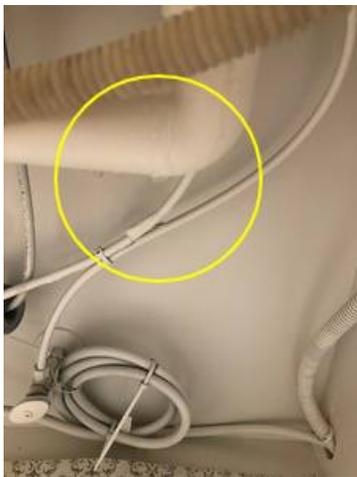
Photo 24-1

One or more sink drains were leaking. A qualified plumber should repair as necessary.

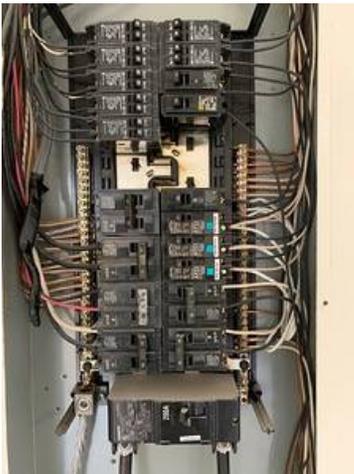
Photo 26-1

Neutral and equipment ground wires were bonded (connected) at sub-panel(s) # C. This should only occur in the main service panel, not sub-panels, and is a shock hazard. Neutral wires should be attached to a "floating" neutral bar not bonded to the panel, and grounding wires should be attached to a separate grounding bar bonded to the sub-panel. Recommend that a qualified electrician repair per standard building practices. For more information, visit:

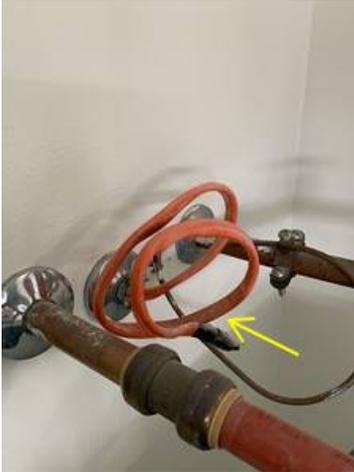
Bare wire ends, or wires with a substandard termination, were found at one or more locations. This is a potential shock hazard. Recommend that a qualified electrician repair as necessary. For example, by cutting wires to length and terminating with wire nuts in a permanently mounted, covered

junction box.

Photo 27-1 Electrical wire for a electric water heater.

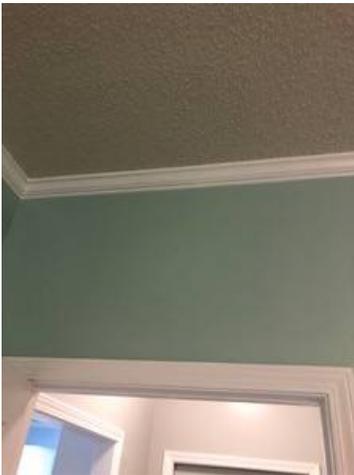
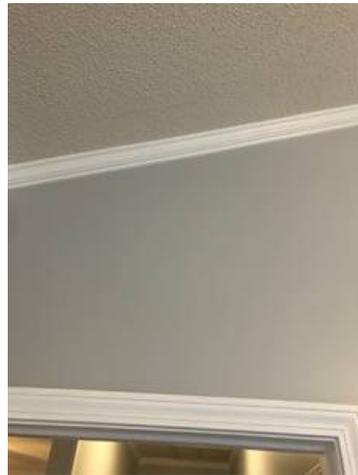
Smoke alarms were missing from one or more bedrooms. Smoke alarms should be installed as necessary so a functioning alarm exists in each hallway leading to bedrooms, in each bedroom and on each level. For more information, visit:

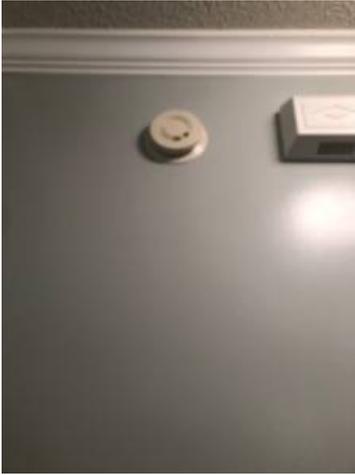
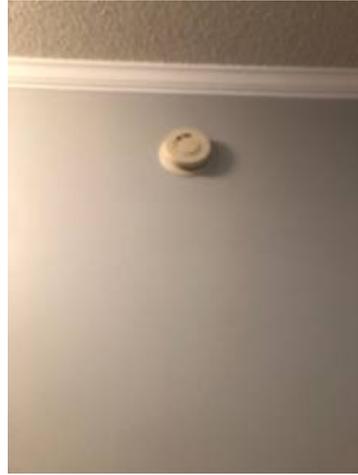
According to [National Fire Protection Association](http://www.nfpa.org), aging smoke alarms don't operate as efficiently and often are the source for nuisance alarms. Older smoke alarms are estimated to have a 30% probability of failure within the first 10 years. Newer smoke alarms do better, but should be replaced after 10 years. Unless you know that the smoke alarms are new, replacing them when moving into a new residence is also recommended by NFPA. For more information, visit:

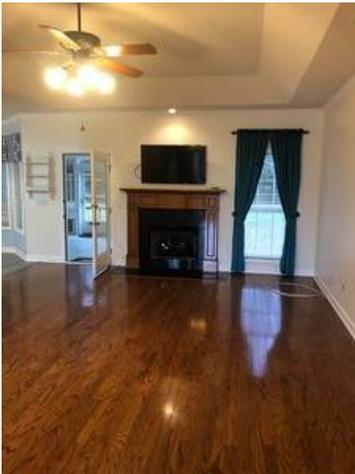
Photo 30-1

No permanently installed carbon monoxide alarms were found. This is a potential safety hazard. Some states and/or municipalities require CO alarms to be installed for new construction and/or for homes being sold. Recommend installing approved CO alarms outside of each separate sleeping area in the immediate vicinity of the bedrooms on each level and in accordance with the manufacturer's recommendations. For more information, visit:

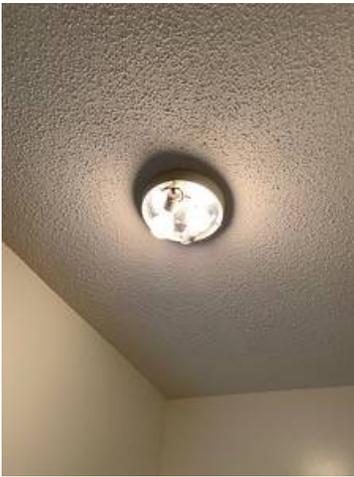
Photo 31-1

One or more globes or covers for light fixtures were missing or damaged. Recommend replacing as necessary to avoid exposed bulbs. With closet lighting or where flammable stored objects are near light fixtures, missing or broken covers can be a fire hazard.

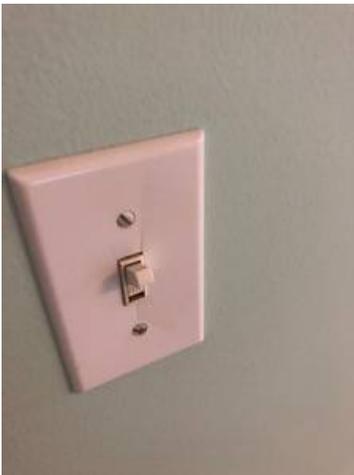
Photo 32-1

One or more wall switches were broken or damaged. Recommend that a qualified electrician replace wall switches as necessary.

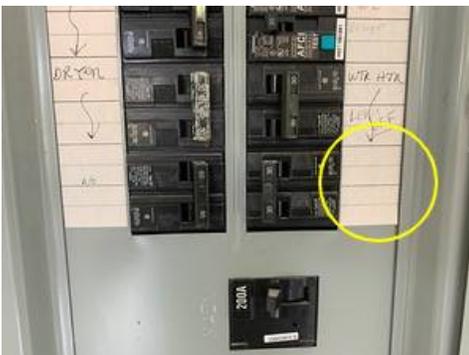
Photo 33-1

The legend for circuit breakers or fuses in panel(s) #C was missing, incomplete, illegible or confusing. This is a potential shock or fire hazard in the event of an emergency when power needs to be turned off. Recommend correcting the legend so it's accurate, complete and legible. Evaluation by a qualified electrician may be necessary.

Incomplete

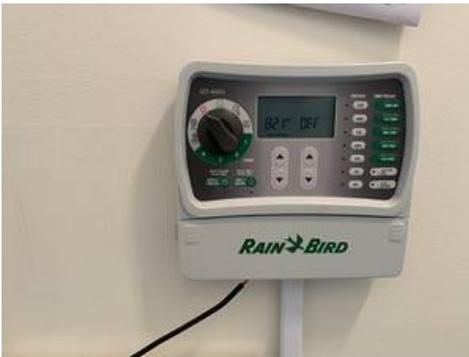
Photo 36-1

Based on visible equipment or information provided to the inspector, this property appeared to have a yard irrigation (sprinkler) system. These are specialty systems and are excluded from this inspection. Comments in this report related to this system are made as a courtesy only and are not meant to be a substitute for a full evaluation by a qualified specialist. When this system is operated, recommend verifying that water is not directed at building exteriors, or directed so water accumulates around building foundations. Sprinkler heads may need to be adjusted, replaced or disabled. Consider having a qualified plumber verify that a backflow prevention device is installed per standard building practices to prevent cross-contamination of potable water. Recommend that a qualified specialist evaluate the irrigation system for other defects (e.g. leaks, damaged or malfunctioning sprinkler heads) and repair if necessary.

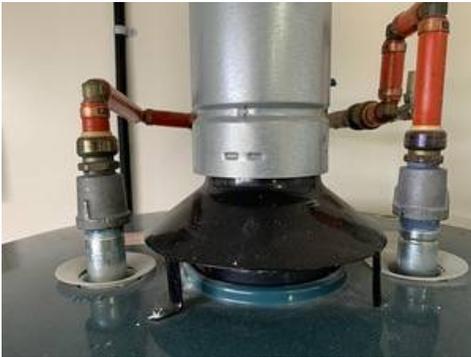
Photo 38-1

One or more plastic water-supply pipes were connected directly to a gas-fired water heater. Most manufacturers of this piping require a flexible metal connector be installed between the water heater and the piping because plastic piping is not rated for very high temperatures and pressure. A qualified plumber should repair as necessary, and per the piping manufacturer's installation instructions.

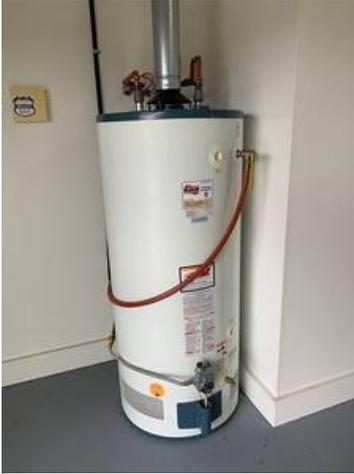
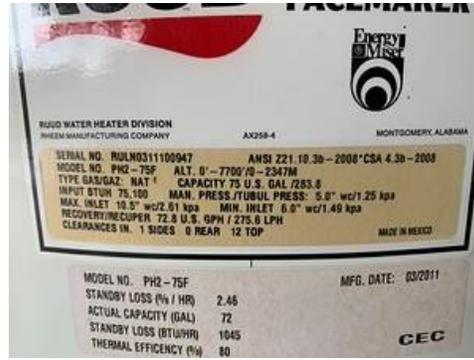
The estimated useful life for most water heaters is 8-12 years. This water heater appeared to be at this age and/or its useful lifespan and may need replacing at any time. Recommend budgeting for a replacement in the near future, or considering replacement now before any leaks occur. The client should be aware that significant flooding can occur if the water heater fails. If not replaced now, consider having a qualified person install a catch pan and drain or a water alarm to help prevent damage if water does leak.

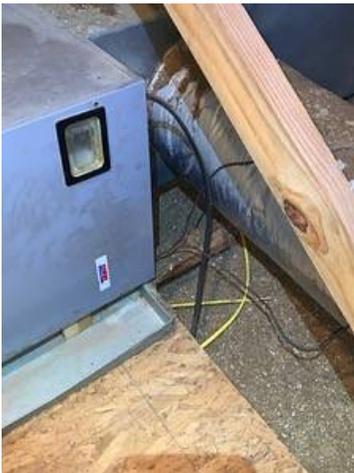
Photo 40-1

A power disconnect for the air handler unit was not found, or it was not in sight of the unit. A power disconnect should be installed within view of the unit to prevent it from responding to the thermostat during maintenance or while off-season. Recommend that a qualified electrician or HVAC contractor install a disconnect per standard building practices.

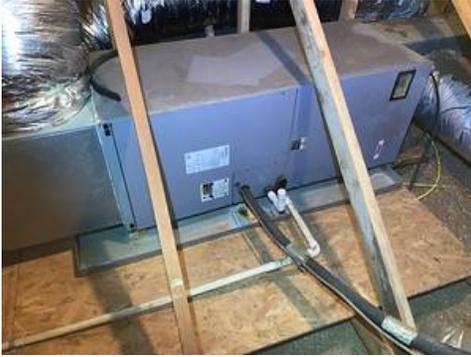
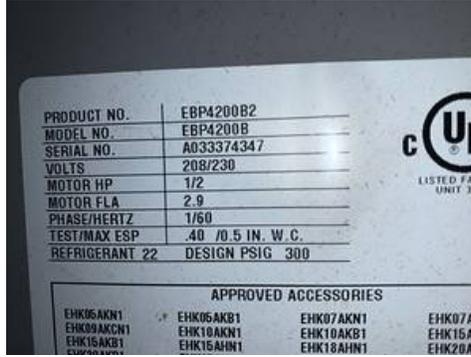
The estimated useful life for most forced air furnaces is 15-20 years. This furnace appeared to be at this age and/or its useful lifespan and may need replacing or significant repairs at any time. Recommend budgeting for a replacement in the near future.

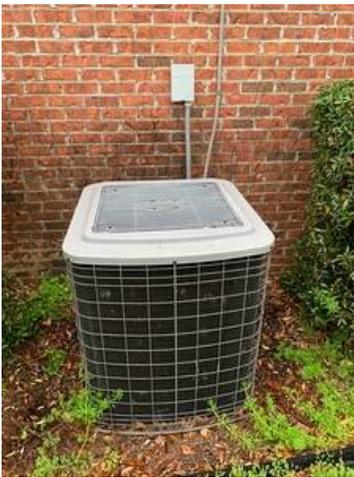
42) The estimated useful life for most heat pumps and air conditioning condensing units is 10-15 years. This unit appeared to be beyond this age and/or its useful lifespan and may need replacing or significant repairs at any time. Recommend budgeting for a replacement in the near future.

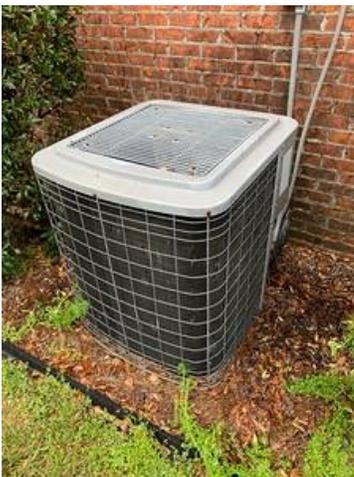
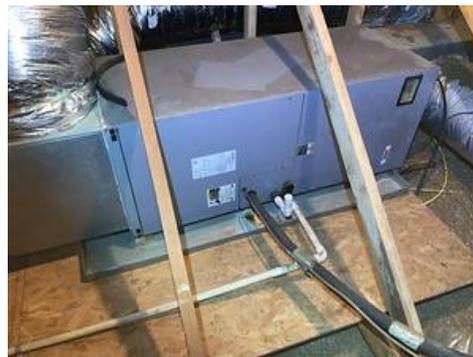
43) The last service date of the forced air heating/cooling system appeared to be more than 1 year ago, or the inspector was unable to determine the last service date. Ask the property owner when it was last serviced. If unable to determine the last service date, or if this system was serviced more than 1 year ago, recommend that a qualified HVAC contractor service this system and make repairs if necessary. Because this system has a compressor and refrigerant system, this servicing should be performed annually in the future. Any needed repairs noted in this report should be brought to the attention of the contractor when it's serviced.

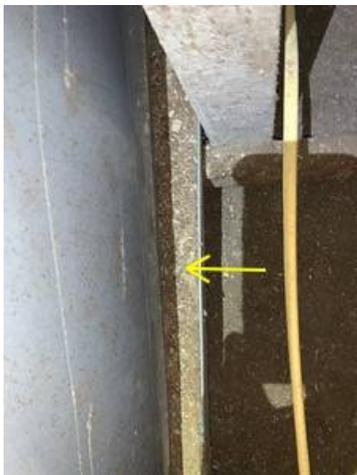
Photo 44-1

44) The auxiliary catch/drain pan in the attic has insulation in at the back of the pan. This could cause the drain to stop up in the event the auxiliary drain system is need. Recommend having a qualified person clear pan of all obstructions.

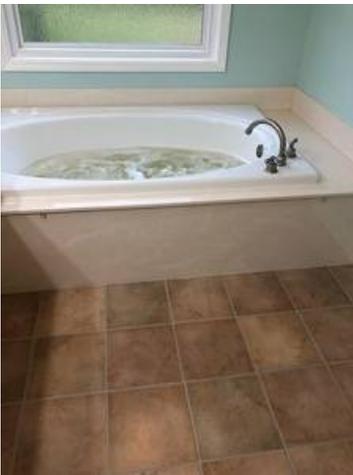
Photo 45-1

No ground fault circuit interrupter (GFCI) protection device was visible for the electric supply to the jetted bathtub. If no GFCI protection exists, then this is a safety hazard due to the risk of shock. Recommend that a qualified electrician evaluate and install GFCI protection if none is installed.

GFCI on sink worked for everything except tub. Unable to see if there is one under tub.

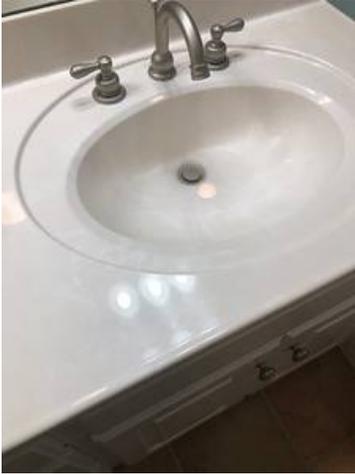
Photo 46-1

The sink drain stopper mechanism at location(s) #A was loose. Recommend that a qualified person repair or replace as necessary.

Not sealing.

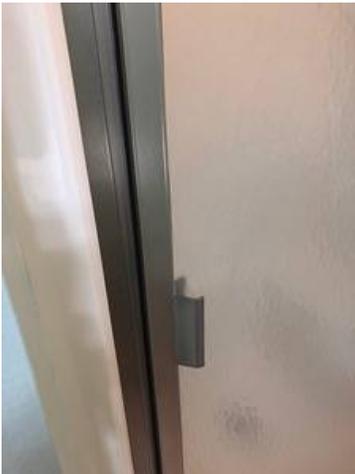
Photo 47-1

The shower door at location(s) #A wouldn't latch or close fully. Water can leak out of the enclosure during showers. Recommend that a qualified person repair as necessary.

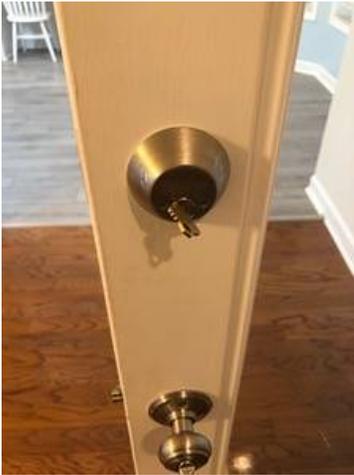
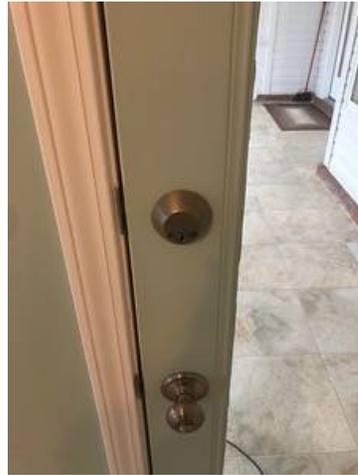
One or more exterior doors had double-cylinder deadbolts installed, where a key is required to open them from both sides. This can be a safety hazard in the event of an emergency because egress can be obstructed or delayed. Recommend replacing double-cylinder deadbolts with single-cylinder deadbolts where a handle is installed on the interior side.

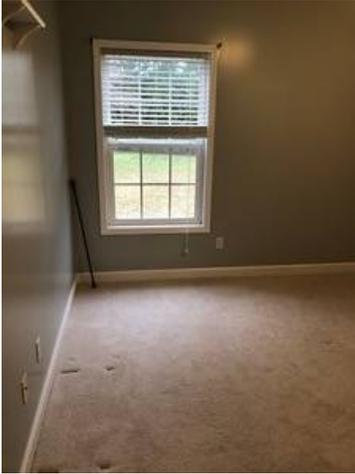
Photo 50-1

One or more bedrooms had windows that wouldn't open or were stuck shut. Unless a bedroom has an exterior entry door, at least one window requires adequate egress in the event of a fire or emergency to allow escape or to allow access by emergency personnel. Recommend that a qualified contractor repair or make modifications per standard building practices. For more information, visit:

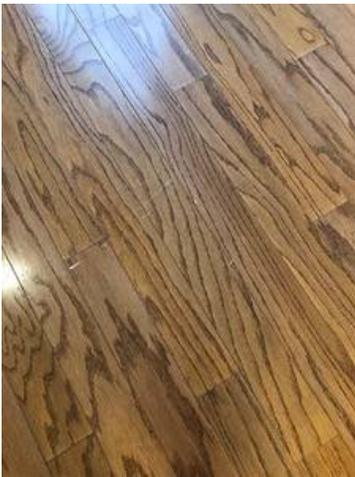
Photo 51-1

51) 🛠️👉 Floor near fireplace...there are a few drops of paint and a minor scratch that may buff out.

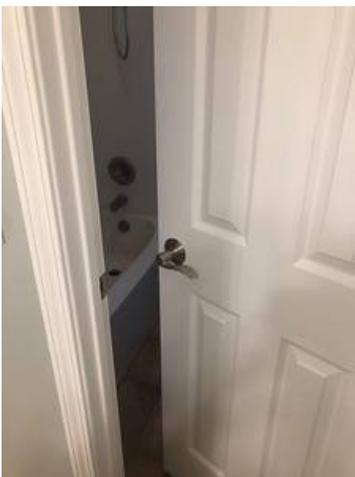
Photo 52-1

52) 🛠️ One or more interior doors wouldn't latch or were difficult to latch. Recommend that a qualified person repair as necessary. For example, by adjusting latch plates or locksets.

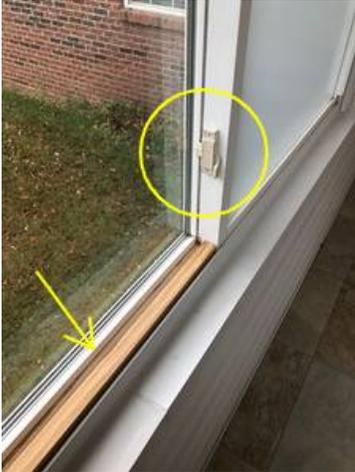
Photo 53-1

53) 🛠️ Lock mechanisms on one or more windows were inoperable. This can pose a security risk. Recommend that a qualified person repair as necessary.

Locks on back porch windows would not lock into place. There were boards cut to fit in the grooves to secure the windows.

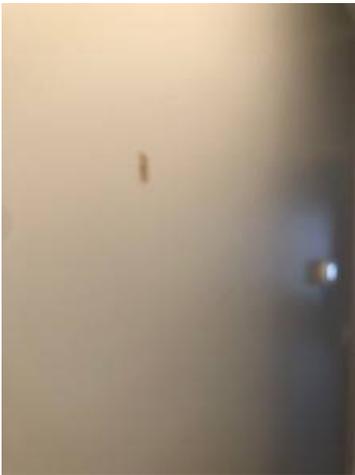
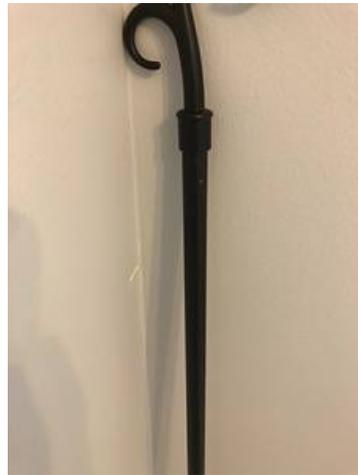
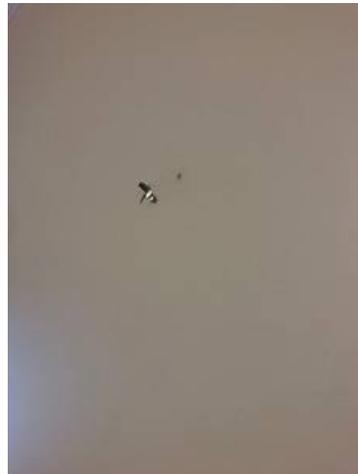
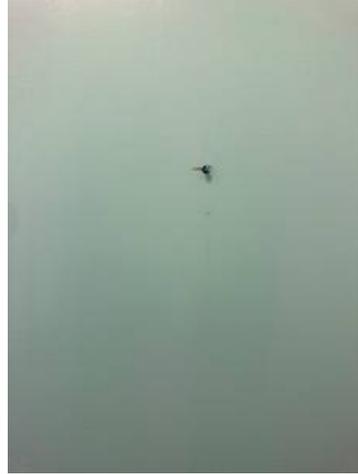
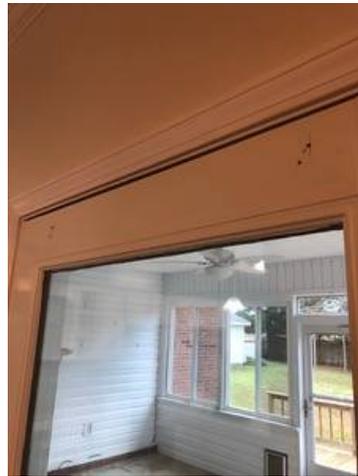
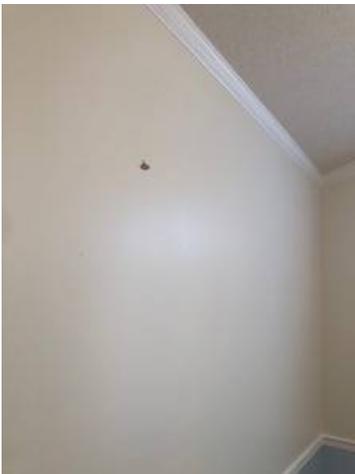
54) 🐛 Minor cracks, nail pops and/or blemishes were found in walls and/or ceilings in one or more areas. Cracks and nail pops are common, are often caused by lumber shrinkage or minor settlement, and can be more or less noticeable depending on changes in humidity. They did not appear to be a structural concern, but the client may wish to repair these for aesthetic reasons. For recurring cracks, consider using an elastic crack covering product: <http://www.reporthost.com/?ECC>

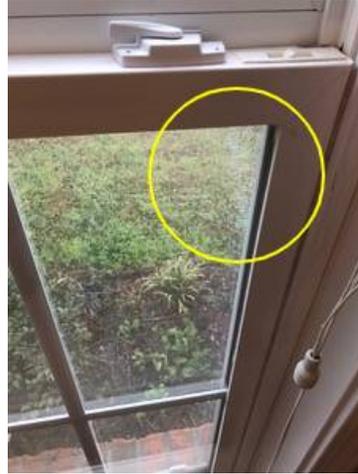
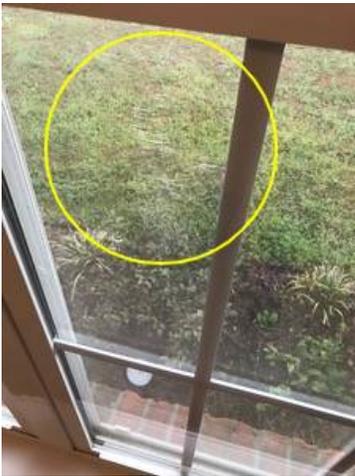
55) 🐛 One or more window screens were damaged or deteriorated. These window(s) may not provide ventilation during months when insects are active. Recommend replacing window screens as necessary.

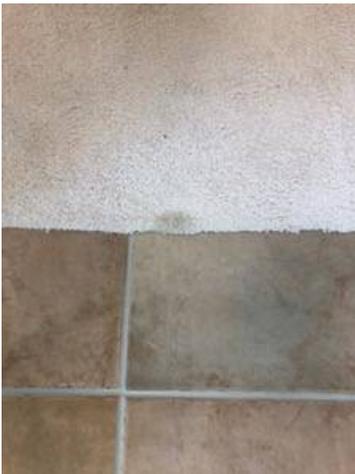
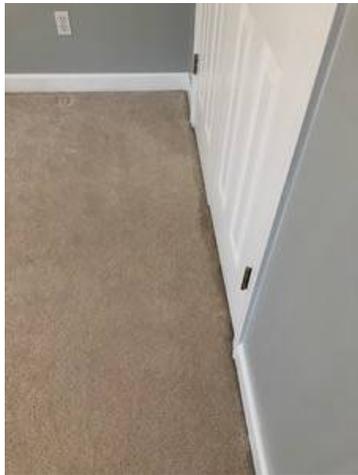
56) Carpet is light (white) throughout. There are a very few spots that need cleaning or that show wear.

Some areas are just where furniture set for years.
