Property Inspection Report

Property address: **703 North Main Road
Dothan, AL 36301**

Inspection date: Wednesday, March 9, 2022

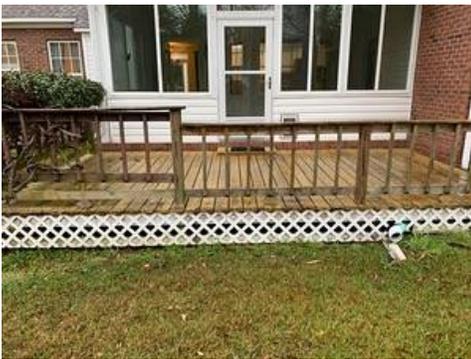
Photo 4-1

Wooden deck or porch surfaces and/or railings were overdue for normal maintenance. Recommend that a qualified person clean and preserve as necessary. Where decks have been coated with a finish such as opaque stains or paint, it may be too difficult to strip the finish and apply anything but paint or opaque stain. Where transparent stain or penetrating oil has been applied in the past, recommend that a penetrating oil be used. For more information, visit:

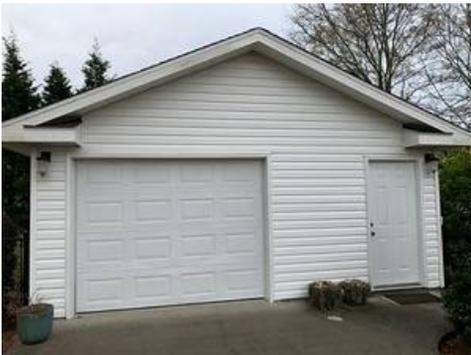
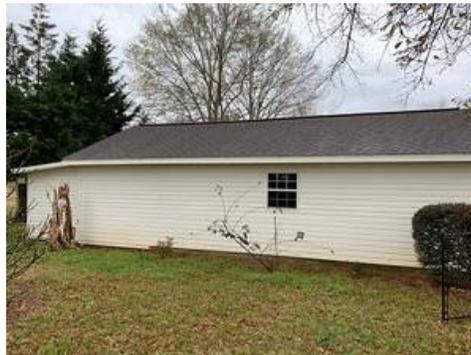
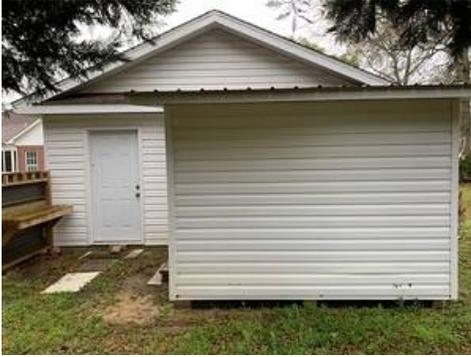
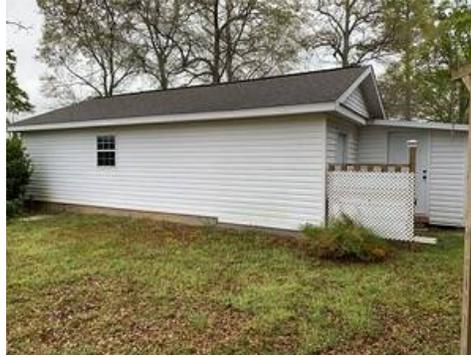
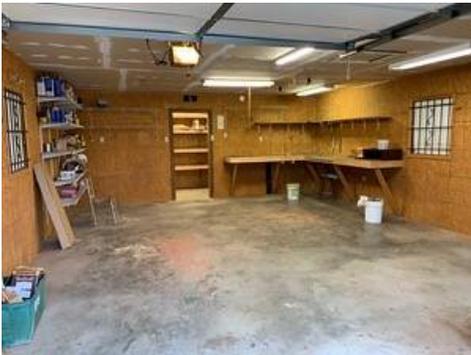
No outbuildings or detached structures were evaluated. They are excluded from this inspection.

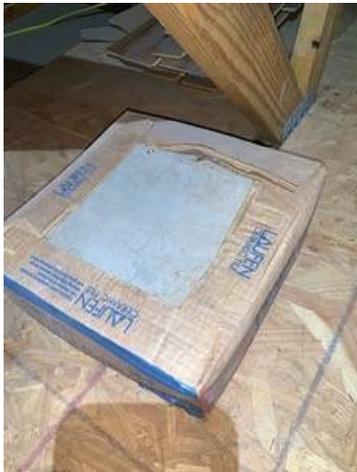
Photo 16-9 Extra materials stored in the attic.

Photo 16-8 Extra materials stored in the attic.

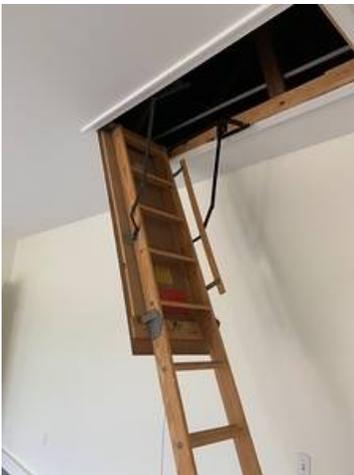
Photo 17-1

The pull-down attic stairs installed in the attached garage ceiling had no visible fire-resistance rating. Current standard building practices call for wooden-framed ceilings that divide the house and garage to have a fire-resistance rating. Installing pull-down attic stairs intended for interior spaces compromises the ceiling's fire resistance. Recommend that a qualified person repair as necessary to restore the ceiling's fire resistance. For example, by modifying, replacing or removing the stairs. Note that commercially made, fire resistance-rated stairs are available. For more information, visit:

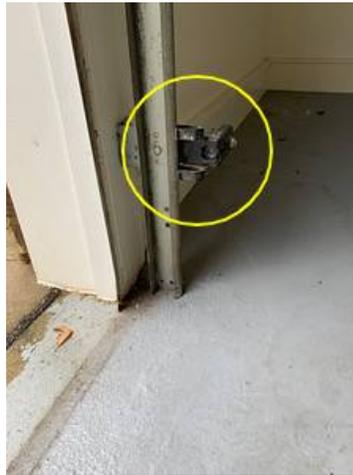
Photo 19-2

The photoelectric sensors that trigger the auto-reverse feature on one or more garage vehicle doors' automatic openers were located higher than 4-6 inches from the floor. This is a potential safety hazard. A qualified person should relocate sensors so they are 4-6 inches from the floor per standard building practices. For more information on garage door safety issues, visit: <http://www.reporthost.com/?GDPES>

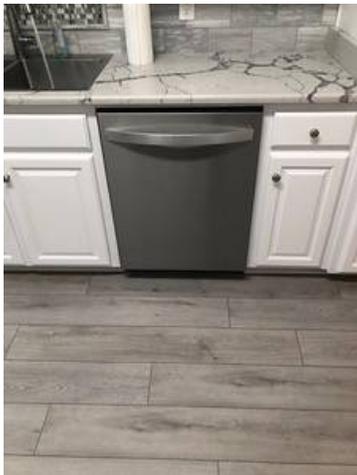
Photo 25-1

25) **i** Appliances - For Information Only

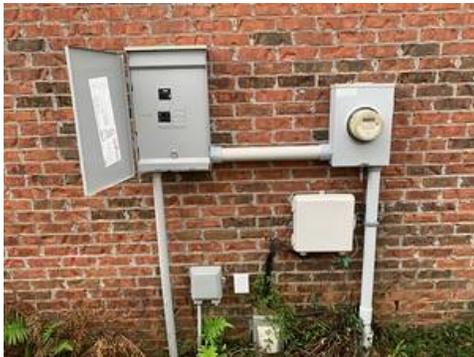
Photo 34-1

Photos of the meter and electrical panels are for information only.

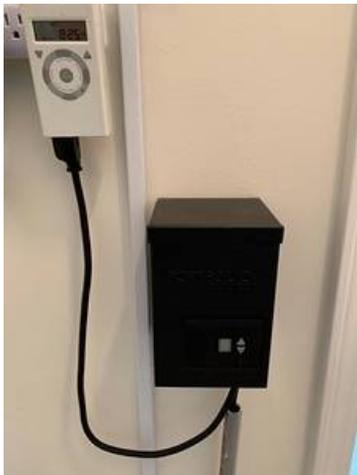
Photo 35-1

35) **i** Outdoor lighting. Photo is for information only.

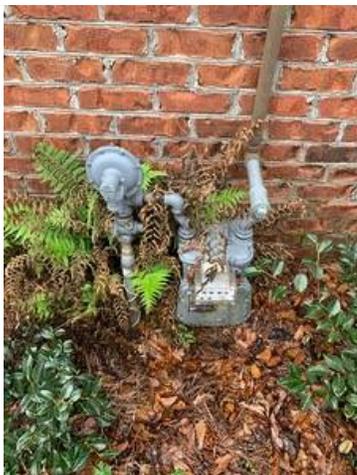
Photo 37-1

Photo of the gas meter is for information only.

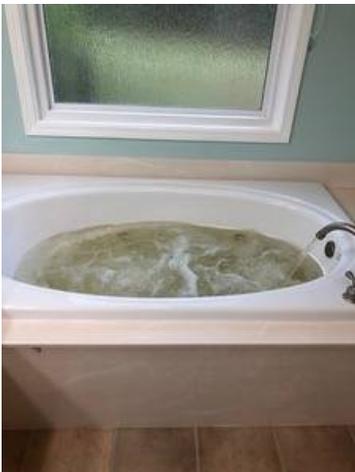
Photo 48-1

Jet Tub - For Information Only

Water a little dark. Water hasn't been ran in a while.

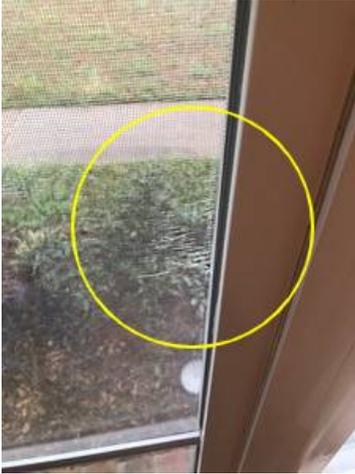
Photo 55-1

This is on front of house and gets a lot of sun.

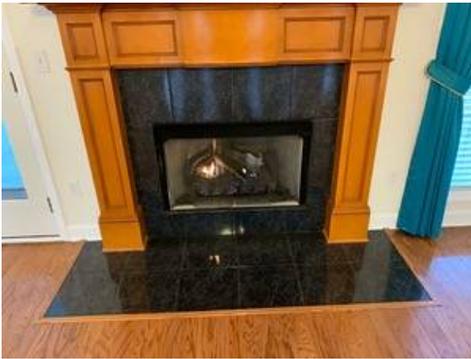
Photo 57-1

Vent-free fireplaces or stoves are not allowed in some municipalities. They must be used exactly as described by the manufacturer, normally for limited times, not in bedrooms and not while occupants are sleeping. They must be serviced periodically. Consult with a qualified HVAC contractor knowledgeable of local codes, and that this appliance be evaluated. For more information, visit:
